EMERGENCY 2007 CYCLONE RECOVERY & REHABILITATION PROJECT
ECRRP-PART-E: Monitoring & Evaluation (M&E)

FIELD VISIT REPORT

Ref. No. M&E-DTL/BWDB/016

5. Activities of Visit : Monitoring of ongoing rehabilitation works of Polders 41/7B, 42, 39/1D, 39/2A and 40/1 in Barguna district.
6. Sites visited : Sites under Polders 41/7B, 42, 39/1D, 39/2A and 40/1

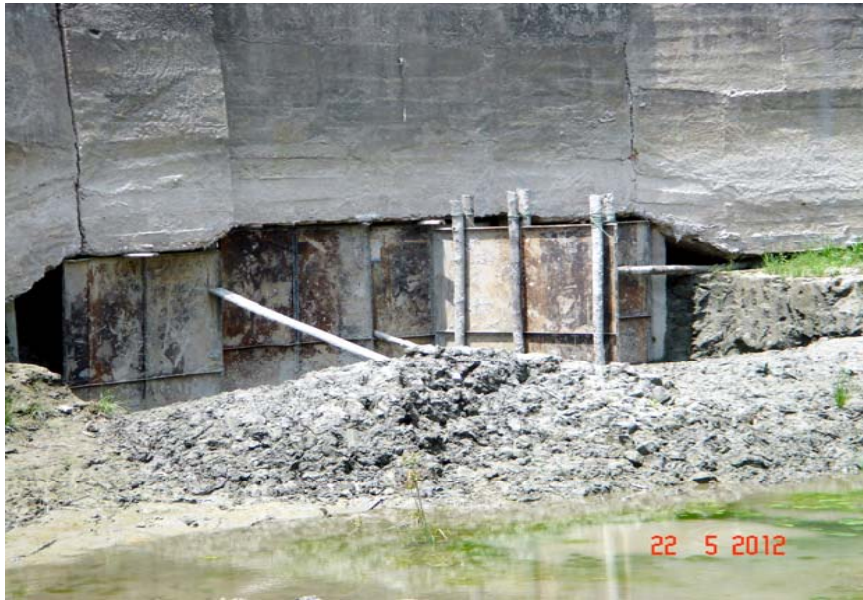
Visited construction site of **new** sluice (3 vent- 1.5mx1.80m) site at Km. 3+500 over Borhar Khal. Sand piling works (482 nos. of sand piles @ 1.0m interval having each pile length of 6.0m and sand pile casing diameter was 300mm) was reported to be complete and results of SPT values have been submitted to BWDB design office to review foundation bearing capacity and giving clearance to go ahead with construction works. Partial procurement of sheet piles has been done. Earth work at both C/S and R/S was in progress. **[Photo- 01]**

Photo-1: Deteriorated condition of damaged Borhar Khal in Polder 41/7B. Still sheets have been placed with support. No activity was noticed in the rehabilitation of the critical structure.

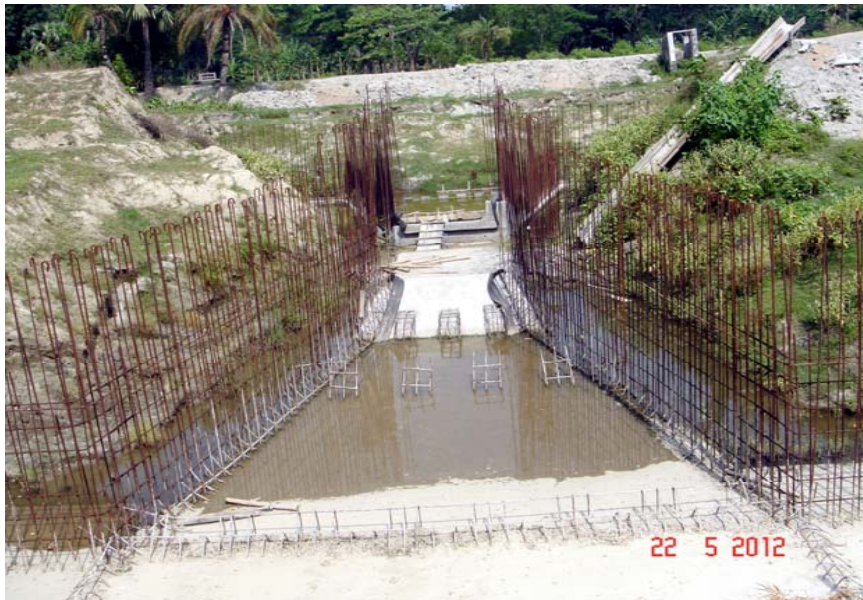
Visited the construction of new Napiter Khal Sluice (1vent- 1.5mx1.80m) site at Km. 33+900. Casting of base slab of box, C/S and R/S aprons, wing and return walls have been done and the site is extremely in good condition for doing the remaining works. **[Photo-03]** Unfortunately, there is no labor and no work for a long time. The site appeared abandoned. The target date of completion of work is 24th May, 2012. The performance of the contractor is very much disappointing. Penal action as per contract should be initiated against the contractor.

Photo-3: New construction of Napiter khal Regulator in Polder41/7B. The critical concrete work up to foundation level has been done. The site was found abandoned due to negligence of contractor.

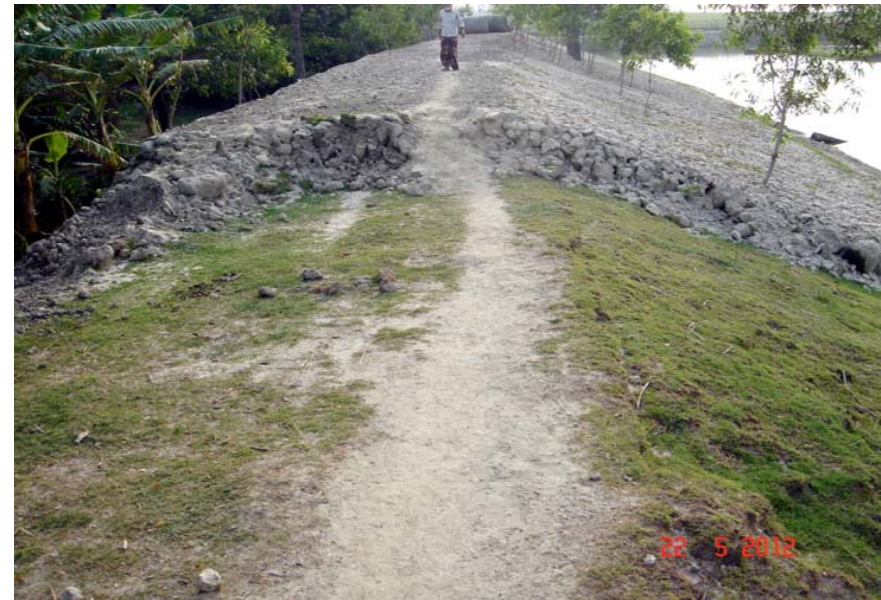
- No base stripping has been done before filling earth. [Photo-04]
- Dug belling has not been done properly.
- No profile has been erected.
- Designed berm width has not been maintained rather existing berm has been spoiled by borrowing earth. [Photo-05]
- Earth is being excavated so close to the R/S toe line that it would be very difficult, if not impossible to bring the dyke to design profile of 1:5 slopes in the R/S. The work done profile is much less than R/S design slopes of 1:5.
- For re-sectioning works, slopes should be benched to form a series of horizontal steps. Then the embankment should be filled to the lines and grades as per design section. This procedure is not being followed.

Photo-4: No base stripping has been done in the re-sectioning of embankment in Polder 42.

Progress of works is slow and only 41% progress of earth work has been achieved so far. The Contractor, DS Consultants and the Field Officials were advised to expedite progress, rectify defects and to ensure quality of works.

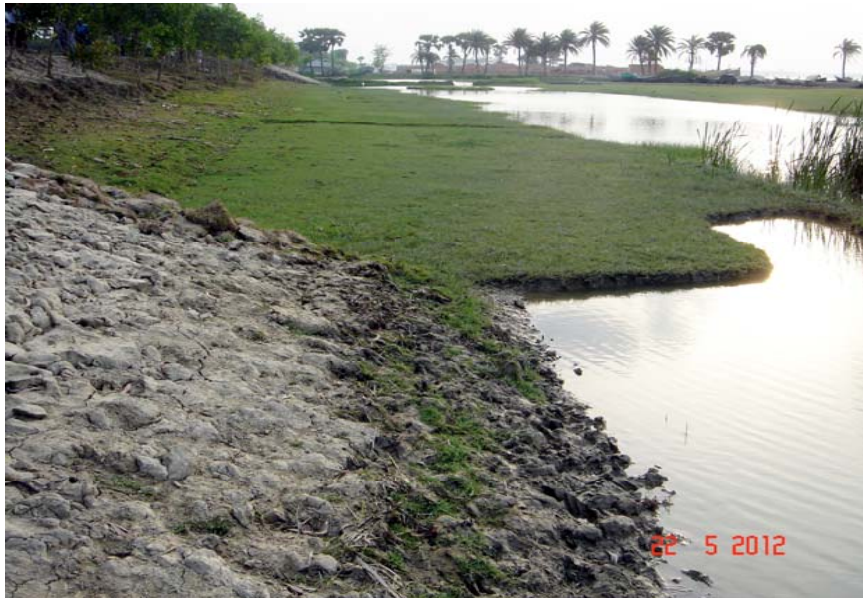
Photo-5: Designed berm width has not been maintained, instead existing berm has been spoiled in Polder 42.

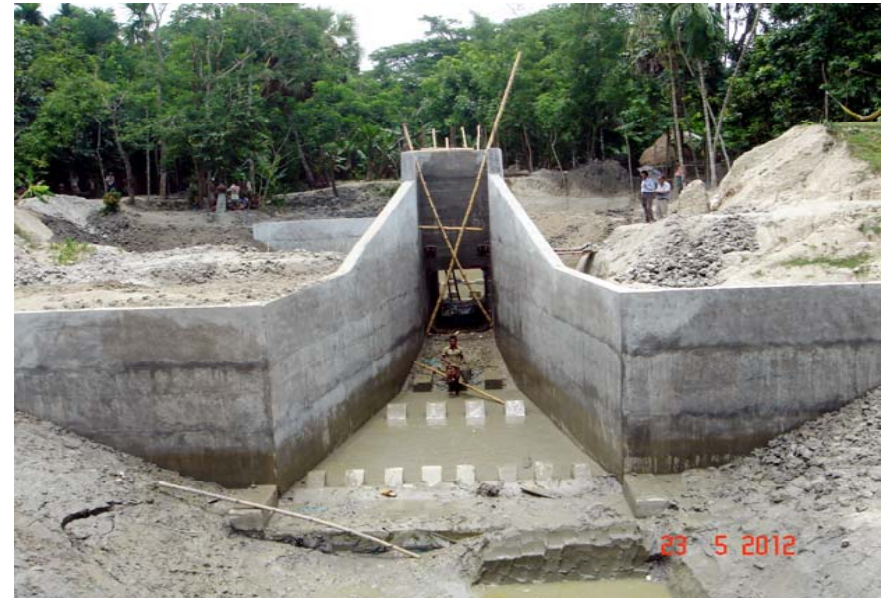
New construction of Gholaghata Regulator (1vent - 1.5mx1.80m) site at Km. 0+000 Km. RCC work up to super structure level has been done. Protective work, construction of diversion channel, installation of gates etc. are yet to be done. Backfilling was in progress. Local earth was being used for backfilling. Overall quality of the structure construction is fairly good although there are some patches of plastering works on concrete surface. [Photo-06]

Photo-6: Construction of new Gholaghata regulator in Polder 39/1D. The progress is satisfactory.

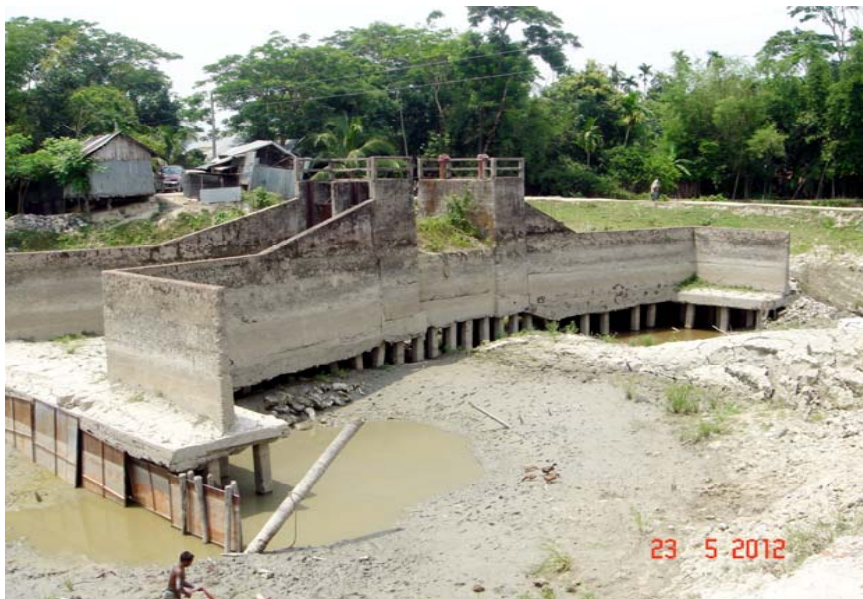
New Bamna Regulator: Sand piling works (317 nos. of sand piles out of 444 nos. @ 1.0m interval each having length of 6.0m and dia. 300mm) was reported to be complete. No physical activity was going on although very good time for construction works prevailed. This is due to sheer negligence of the contractor. [Photo-07]

Photo-7: Deteriorated condition of damaged Old Bamna sluice in Polder No.39/2A. No activity in the field. Immediate rehabilitation is essential.

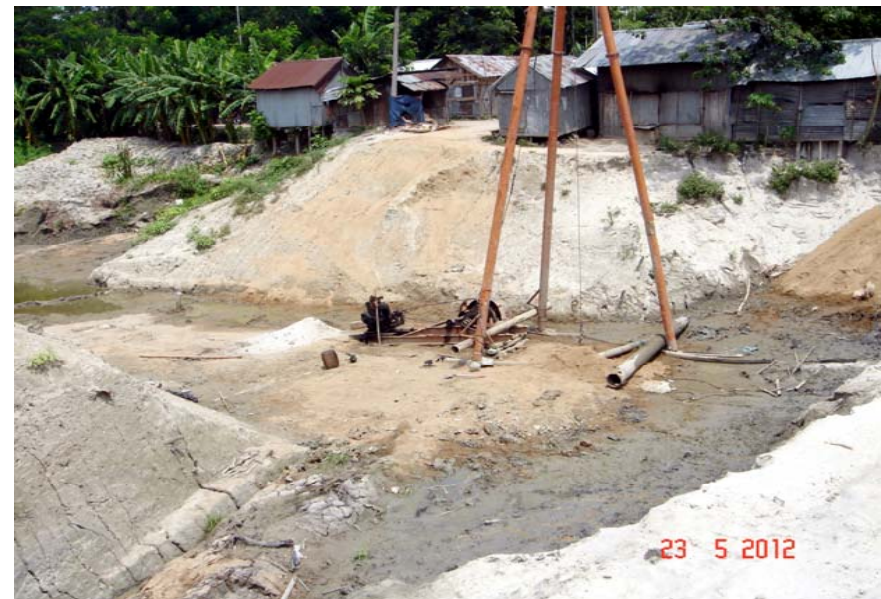
Rehabilitation of existing Bamna Regulator: The structure had been outflanked during the cyclone Sidr. Rehabilitation works include driving thick sheets to intercept seepage flow, backfilling at wing and return walls, base of structure, placement of CC blocks over inverted filter, loose aprons with slopes at both C/S & R/S of structure and repairing of wing and return walls. A special type of design matching with technicality of the rehabilitation requirement has been made by the DS Consultants. It appeared that the contractor is in a fix as to how to execute the work of damaged structure per design. No doubt that the damage is such as the repair work is quite challenging. In the meantime, a very good time for construction has been lost due to negligence and hesitance of the contractor. The execution of work needs intense monitoring and guidance by design and highly experienced technical personnel. The M&E Consultants is of the opinion that once monsoon rainfall starts, the ditch will be filled with water making the site unfit for any work till the next dry season. [Photo-08]

Photo-8: Poor progress of the new Bamna regulator adjacent to the Old Bamna regulator in Polder No.39/2A.
